Case Study

Screw Pump Failure

ERIKS rectifies failing screw pump repair from another engineering company

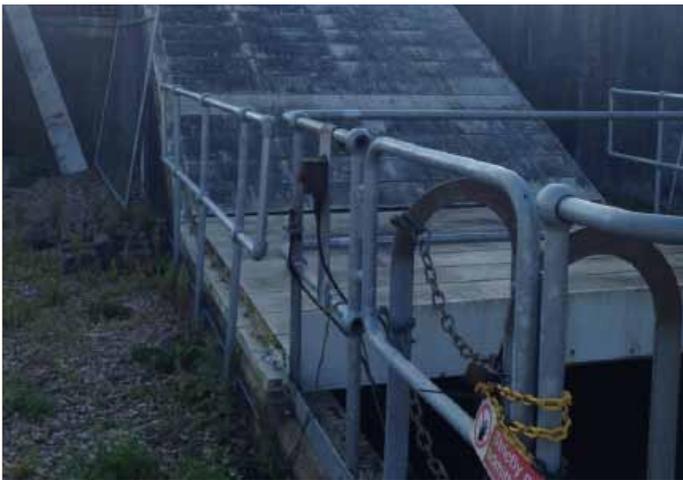
Once we had undertaken a site inspection on the pump it was found that the gap between the flighting and the concrete screed was approx. 60mm, the optimum gap should be 6mm. This extensive gap was the main factor in why the pumping capacity of the pump was greatly reduced

In discussions with the client it was made clear that replacing the screw, with its very long lead time, 24 weeks, was not an option as the treatment process would not survive the reduced RAS flow, thus threatening the aeration lanes.

The pump clearly required repairing in a short space of time as the reduced flow rates were already having an effect on treatment of the wastewater.

ERIKS came up with a plan that would return the pumping flow of the pump to full capacity in the shortest possible time span.

The screw was removed along with the screeding, that was also replaced. The screw was then set up on running bearings, cutting equipment was set up which used the centre shaft of the auger as a datum
