Leaking Cooling Coil Sparks Full Pump Overhaul

Industry Sector:
Water & Wastewater

Application:
Bore Hole Pump

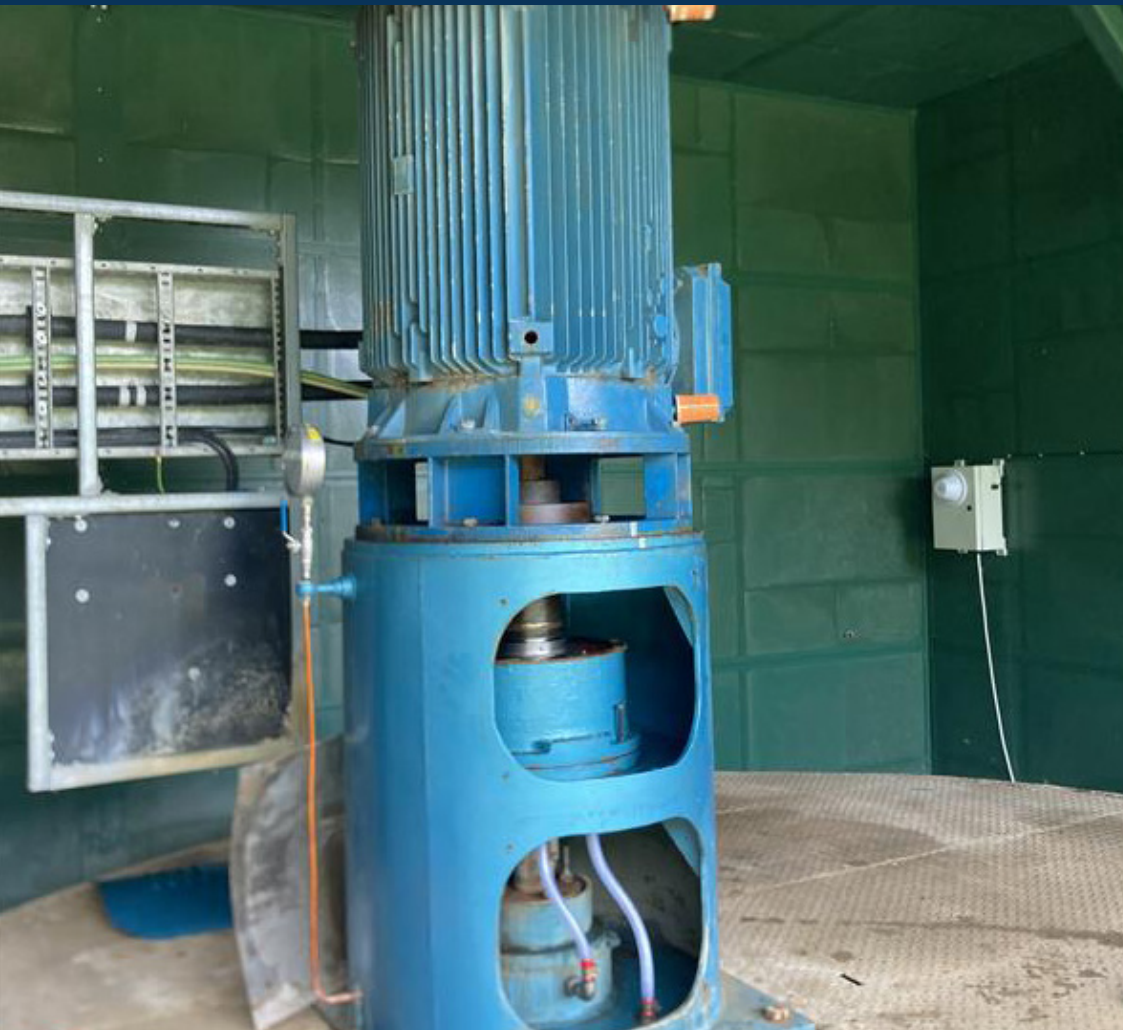
Once we had the pump on the ground, our team transported it to our Norwich Workshop for a detailed inspection. The initial strip-down revealed a serious issue – the thrust pad material had completely eroded down to the bare plate. Even more concerning, the bearing housing was completely dry.

After further analysis, we traced the failure back to a leaking cooling coil inside the housing. This leak had flushed out all the oil, leaving the thrust collar and journal bearing running without lubrication. With only water in place of oil, the white metal bearing was quickly worn down – resulting in overheating and total seizure.

First, all three internal shafts were checked for straightness and then precision-machined to accommodate new bronze sleeves. The journal bearing, which had suffered extensive damage, was stripped of its remaining white metal.

We then re-applied a high-quality BS3332 alloy C white metal and proof-machined it, deliberately leaving a 3mm surplus for final finishing.
