Repair or replace for the best returns?

ERIKS showed a dirty water pump wasn't all washed up

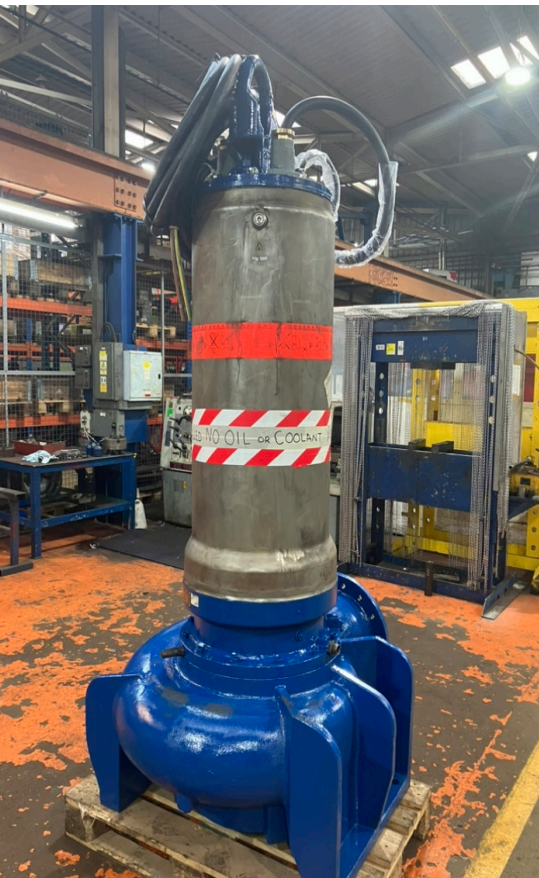
Complete unit re-assembled, ready to be returned

With the capability to press out the old shaft and press a new one back into the rotor, there was no need to replace the entire shaft assembly. ERIKS replaced the shaft alone with a new one reverse engineered in stainless steel. The worn cast iron impeller was also swapped for a replacement, cast in Super Duplex stainless steel.

Stainless steel was also used for a replacement for the worn volute wear ring and suction wear ring.

Various seals, the drive end and non-drive end bearings, O rings and cables were replaced with new, but the previously condemned stator winding was tested and proved to be undamaged. The rusted exterior was grit blasted, then coated with a Loctite protective coating, as was the volute wear ring and other volute casing internals.

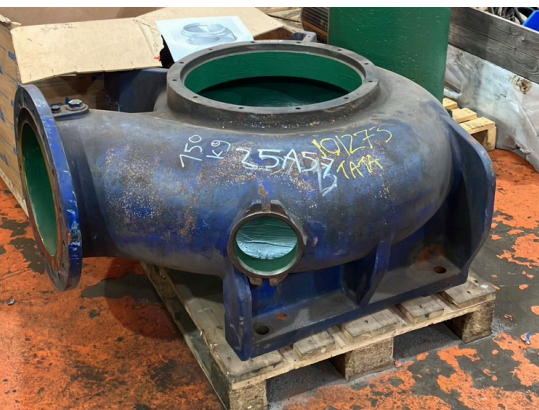
A failed dirty water return pump had been partly stripped down and inspected on-site by the OEM, who condemned it and recommended a completely new replacement. Among the components assessed as needing replacement were the stator (described as having gone to earth), the complete shaft assembly – including the rotor – and the volute body.

Though a specific or isolated cause of the pump failure was difficult to pinpoint, ERIKS identified a number of issues, which together could have lead to the failure. These included over-speeding – causing recirculation erosion under the casing wear ring; particles in the pump fluid – clogging the mechanical seal, leading to loss of compression; isolation problems with the non-return valve – causing the pump's turbine effect or sudden reversal to create excessive torque on the shaft.

Dirty water return pump before undergoing overhaul
