# Case Study

Application:  
**MOTOR REPAIR**

# Repair claims victory over costly replacement

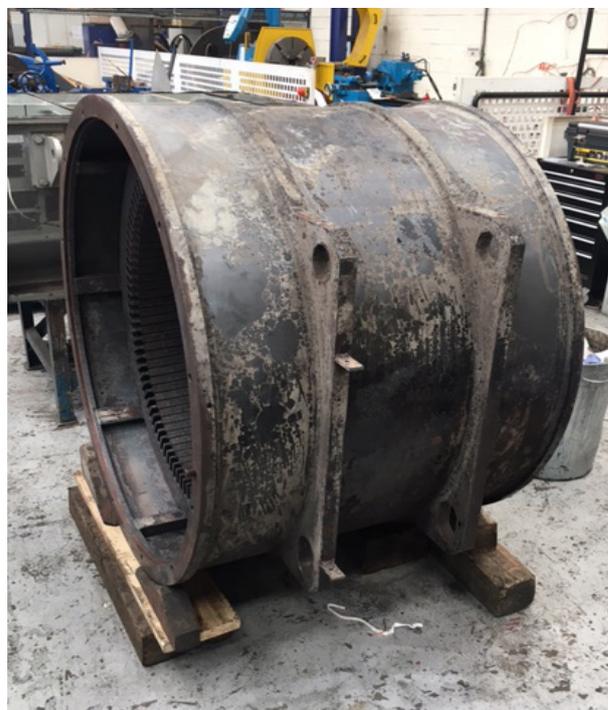
One UK steel manufacturer was experiencing issues with a Leroy Sommer SN 172209-2 motor, where an inter-turn fault on the stator windings and further problems on the laminated iron core pack were creating inconvenient downtime.

Several internal meetings were held, and a solid repair programme was created, which included the construction of various specialised jigs that would enable the support of the core and keep a mechanical datum.
