# Case Study

## Horizontal Aeration Lane Equipment

ERIKS successfully repairs potentially catastrophic aeration lane equipment breakdown

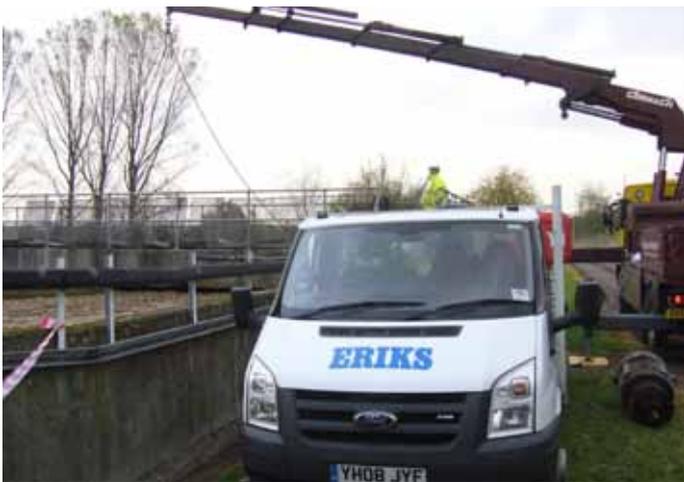
With all these factors to consider ERIKS had to come up with a plan to remove the unit from the ditch without any draining down. With the ditch being full of zero visibility water and around 4m deep, the removal was set to be a challenge.

It was agreed that placing any person in the ditch was not an option. Although divers have been used in previous occasions, this was not possible during this project as the ditch was fast flowing with heavy deposits. Combined with a unit that has many sharp edges, the risk of possible injury was too great.

It was decided that we would use a crane mounted hydraulic grab, the grab could be lowered into the water traversed across until we hit the unit, then raised and lowered to lift out the unit to a point where the correct use of lifting slings could then be applied.

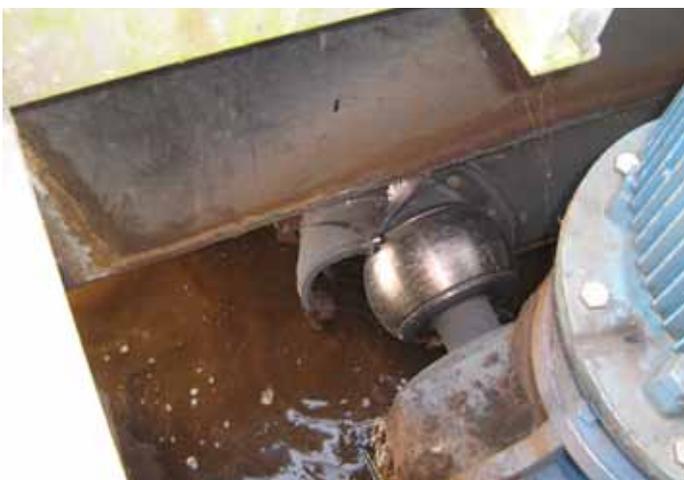
This was done with great success, finding the unit almost on the first go, followed by the successful lifting of the unit from the ditch.

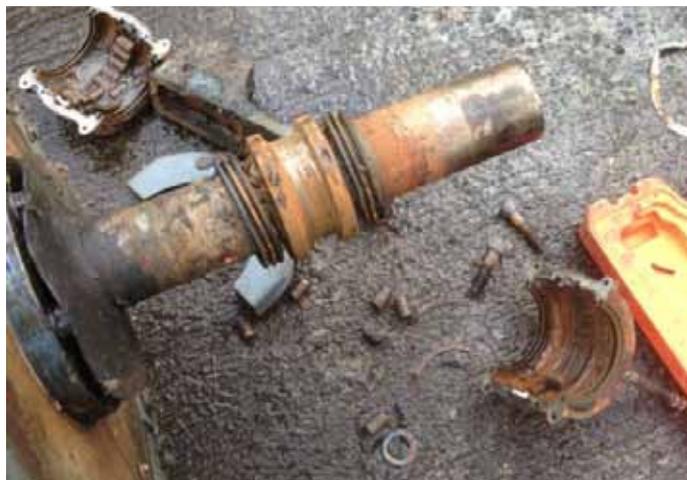
With the unit out, a full inspection indicated that we could undertake a refurbishment of the unit rather than a full replacement.
