Industry:	Pharmaceutical
Application:	Cooling Tower Drive
Actual Saving:	£
Payback Period:

Obsolete Parts Sourced to Repair Aging Cooling Tower

ERIKS provides solution when faced with obsolete parts, to repair a critical cooling tower at a chemical plant.

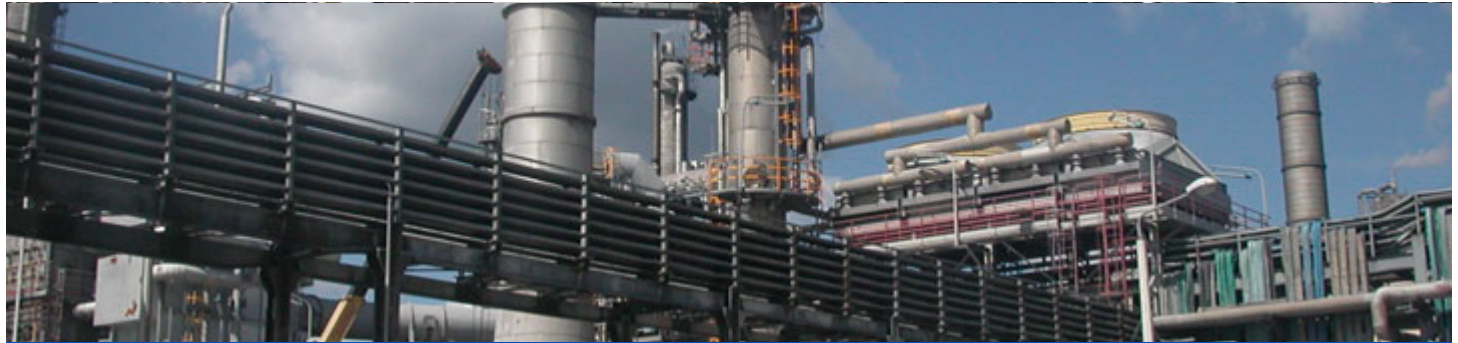
The cooling tower was over 20 years old and the flexible coupling elements had worn out and the hubs had corroded. There were no obvious identification markings to be seen, and even if a manufacturer could have been identified the likelihood was that the spares required would no longer be available.

ERIKS were contacted and were able to quickly identify a complete new coupling assembly that would solve the problem.

The Rexnord Addax Composite Coupling was specified, with bored and keywayed stainless steel hubs to fit the existing motor and gearbox shafts. The composite centre member was able to provide the exact same distance between shaft ends (DBSE) which made the new Addax Coupling a "drop in" replacement.
