PROBLEM SOLVER

SPEEDI-SLEEVE SHAFT REPAIR KIT

Food and
Beverage

Ref: PS075

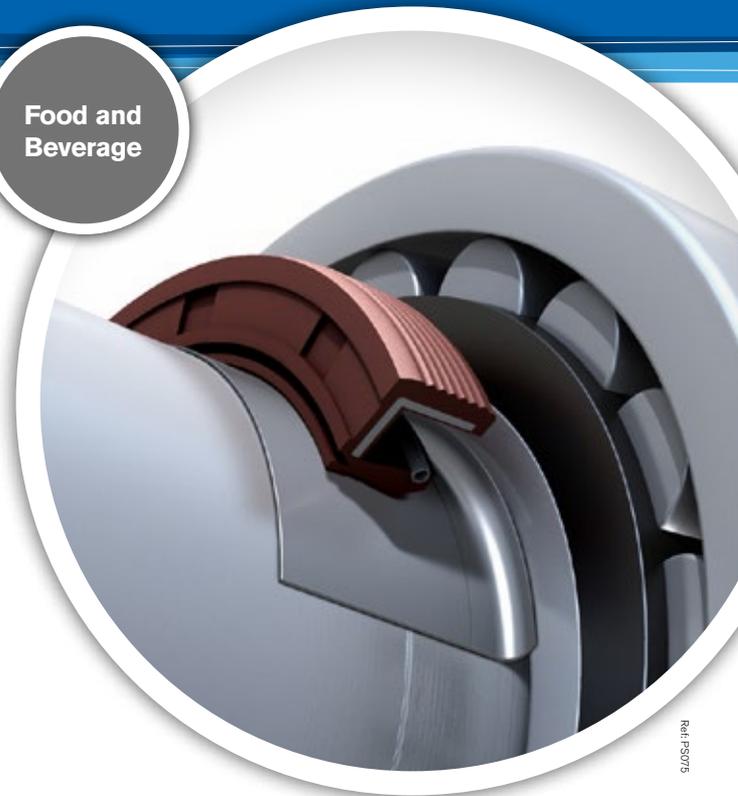
After discovering an oil leak, the dust was found to be working its way past the sealing lips on both the input and output shafts of the conveyor drive. The seals were subsequently replaced, but oil leaks continued, risking product contamination. Further investigation showed that dust ingress had caused the shaft to wear underneath the sealing lip, leading to premature seal failure and leakage.

Solution: The company was recommended to install **SKF Speedi-Sleeve**. Made from a proprietary stainless steel material, these are a well-proven solution to the problem of worn shafts.

Instead of removing and re-machining the shaft, which can be incredibly time-consuming and costly, an SKF Speedi-Sleeve can simply be fitted over the worn section. This can be done in a matter of minutes, instantly providing a wear-resistant, highly-finished surface that creates an optimised seal counterface, minimising seal wear and protecting the shaft.
