Saving £0.5m is no small potatoes

ERIKS expertise delivers value when the chips are down

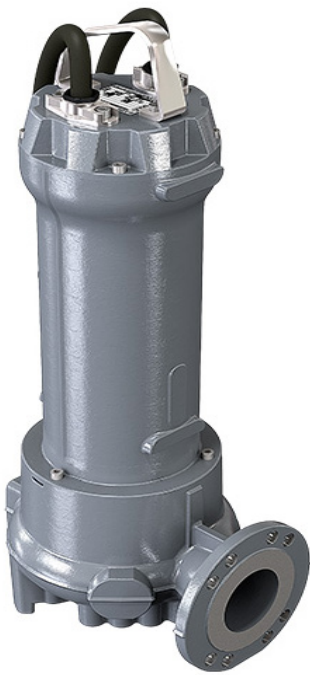
Submersible pump used within the application

When connected to 8" diameter pipework, the industry standard for a pump's self-cleaning velocity – without causing excessive increased wear – is between 2.7m/sec and 3.5m/sec. As the ERIKS pump engineer realised, the customer's pumps were operating below the self-cleaning velocity for the size of pump and pipework. As a result, the suction apertures were becoming increasingly clogged with silt and sand.

Because the pumps were being operated with a Variable Speed Drive, they could be driven at overspeed. ERIKS know-how enabled the engineer to quickly calculate the required velocity to effectively clear the sediment from the units. His workings showed that by operating the pumps at 120%, a velocity of 3m/sec with a flow rate of 330m³/hr would be achieved – which would have the desired self-cleaning effect.

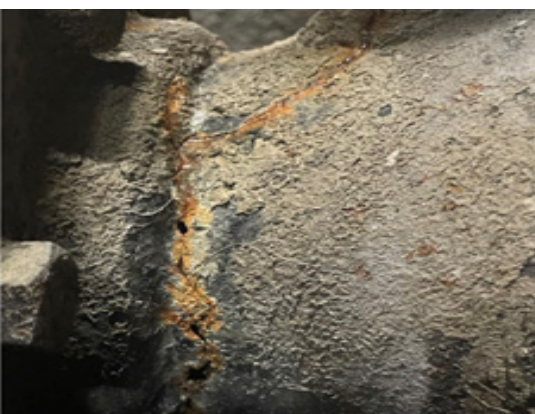
The customer utilises two submersible pumps to remove the effluent and pump it out for disposal. When the first pump failed, the cause was traced to a split outlet pipe. Until this was repaired, the customer relied on their standby pump, but this subsequently also failed due to a seized bearing.

Split in the outlet pipe

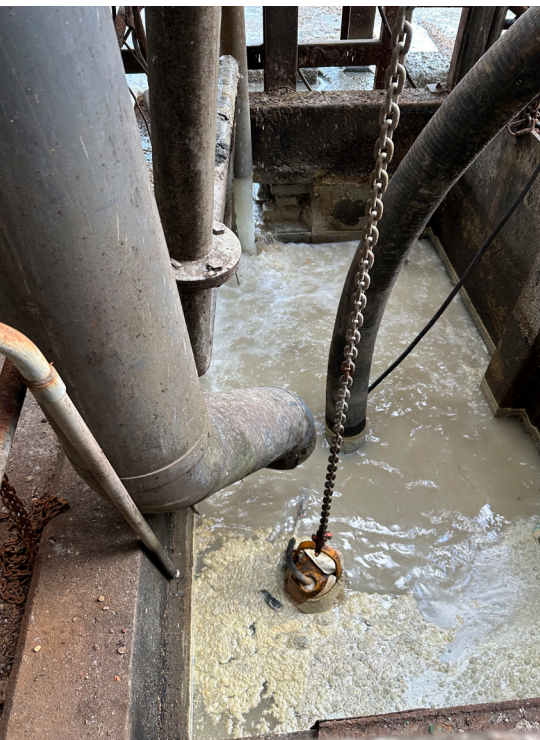
Submersible pump in-situ

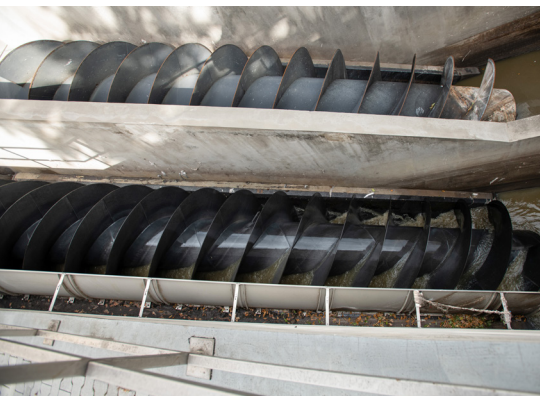
Further upstream in the process, the customer utilised two Archimedes' screws to remove water from the effluent pit. These were failing, and ERIKS arranged two emergency hire pumps to enable the production process to stay operational.

Two archimedes screws tasked to remove water from the effluent pit

Using his pumps know-how, the ERIKS engineer recommended replacing the Xylem pumps with two vortex pumps. These allow larger solids to pass without being chopped up and without damaging the pumps. Since the solids remain the same size, they are then screened out at the next stage of the filter system, and prevented from being discharged into the sea.
