Delivering significant savings on a tray

How one new pump washed problems away

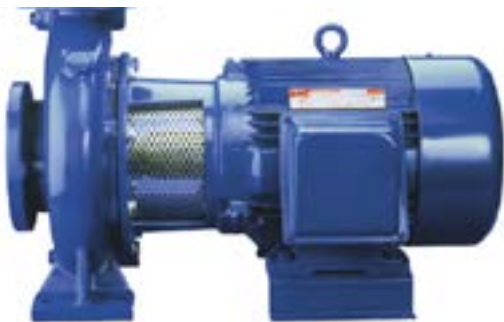
Apex TC Pump

And lastly, in a simple but effective fix, the choice of a vertically-mounted pump model – the Apex TC 50- 200 15/2 – was advised, to ensure it wouldn't flood even if the sump wasn't drained.

Addressing the chemical corrosion first, the engineer recommended a pump manufactured from 316 stainless steel for the volute casing, impeller and shaft. To prevent air becoming trapped in the seal – which was causing the pump to run dry – a flexible bellows mechanical seal, incorporating silicon EPDM elastomers, was specified. This seal also features vent pipes to allow air to be released before priming.
