# Thermal imaging delivers big returns

Cutting-edge condition monitoring delivers the dairy

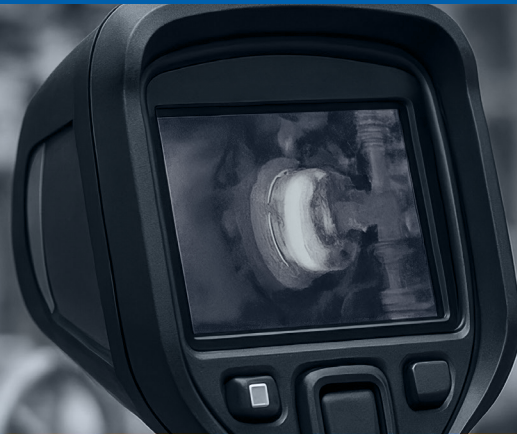
One clear example was an aluminium shroud atop a steam pipe. The valve beneath had been repaired, but the insulation had not been replaced afterwards – a common issue in busy production sites. Thermal images highlighted significant heat escape from these zones.

The full assessment uncovered over £400,000 in avoidable energy losses across the dairy. The report was shared with the ERIKS team, who collaborated with local insulation partners to swiftly action the repairs. In some cases, parts were supplied directly by ERIKS, while other fixes were handled internally by their own team.
