# Turning up the heat on electrical efficiency

Uncovering electrical faults before they reach failure

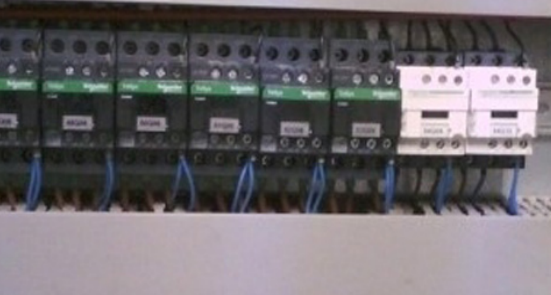
The high-resolution thermal data revealed multiple areas of concern. Several panels displayed signs of possible overloading, with component temperatures exceeding 70°C in certain instances. In total, over 14 anomalies were documented, each with detailed temperature measurements, severity ratings, and corrective recommendations. All images and results were compiled into a clear, structured report — allowing the customer to see precisely where action was needed.

Each fault was categorised by severity using ERIKS' industry-aligned fault rating method, helping the maintenance team prioritise repairs. Issues ranged from localised hot spots and phase imbalances to ageing transformers and resistors nearing the end of their operational life.

The thermographic survey gave the customer immediate visibility of hidden electrical faults, many of which would not have been detected during routine inspections. Armed with ERIKS' insight, the engineering team was able to take fast, targeted action — checking loading conditions, replacing overstressed components, and proactively addressing wiring issues before they could escalate.
