# Trapped losses. Released savings.

Thermography exposes failures and improves efficiency

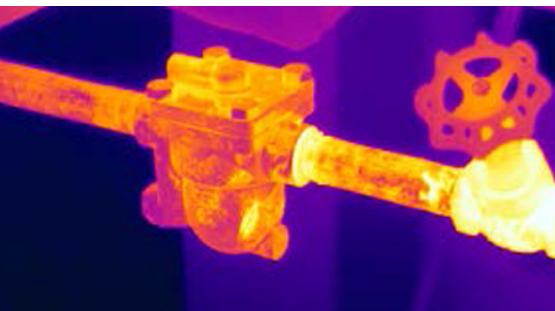
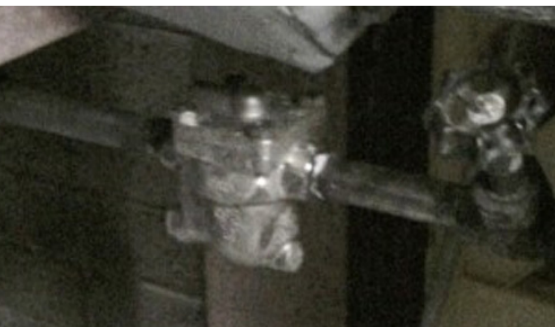
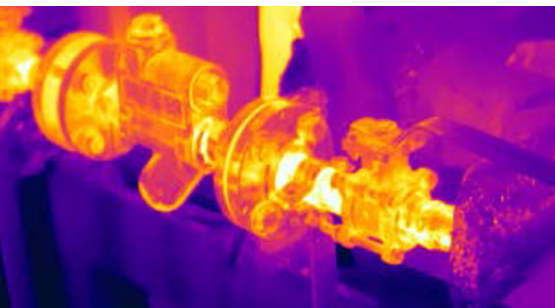
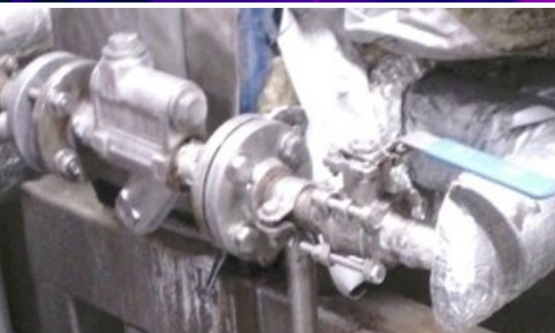
A total of 20 traps were inspected across the facility, from boiler house calorifiers and hot water skids to steam-fed cookers, smokers and tunnel systems. Of these, six traps were identified as faulty, most commonly due to being stuck open or not closing properly. In these cases, temperature differentials were minimal — indicating poor condensate removal and energy loss due to live steam passing through.

Several other traps were marked for ongoing monitoring. These included traps showing low activity — either due to being in standby mode or simply operating intermittently due to current load conditions. All results were clearly documented and matched with the corresponding plant location, component ID and recommended action.

For the traps that were failing, or stuck open, immediate replacement or repair was advised. By addressing just those six identified failures, the customer stands to significantly reduce energy waste and protect downstream systems from potential wear or performance degradation. Traps marked for observation will be rechecked in the next scheduled survey.
