Reduced maintenance, improved productivity

River Intake Pumps

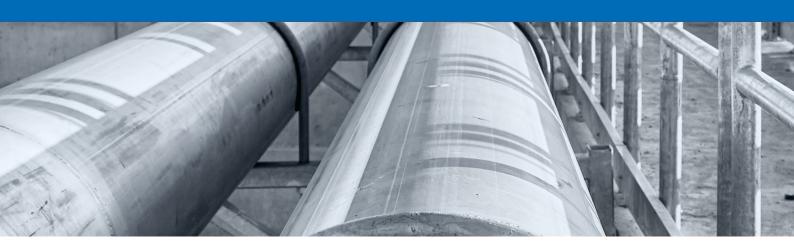
Old river intake pump ins-itu

Refurbished and repainted pipework

Refurbished pipework with WRAS-approved coating

The ERIKS engineering team after completely stripping down and cleaning the pump, undertook NDT crack testing. All items were 3D scanned to provide a permanent database of all components, The database will enable ERIKS to manufacture spares prior to extracting the pumps and motors from this plant room in the future, therefore reducing the time these critical assets are off the application. There is the added benefit of maintaining control on quality and consistency on all future repairs too.

All wear items were replaced including, shaft sleeves, rubber cutlass bearing bushes, wear rings and shafts. In order to meet industry defined Regulation 31 and WRAS approval, all areas in contact with the pumped water were either coated with an approved coating or were manufactured using industry and OEM compliant materials.
