# PROBLEM SOLVER

## BEARING FAILURE SOLVED

**Problem:** Faced with regular bearing failures on the blade support of a concrete pipe-slotting machine that would cause eight hours of downtime each time, a UK-based concrete pipe plant turned to NSK for assistance.

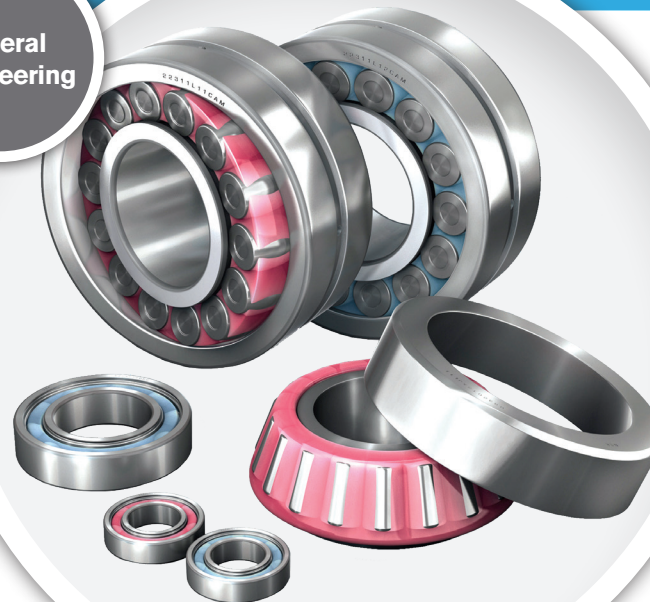
**Solution:** As part of NSK's AIP Added Value Programme, a team of engineers scrutinised the application and determined that the ingress of concrete dust into the bearings was the root cause of the problem.

The fine dust produced when cutting or slotting concrete pipe can be extremely damaging to standard shielded deep groove ball bearings. Dust gets behind the seal and contaminates the lubricating grease, which as the UK concrete pipe producer now knows, can prove extremely costly.

To achieve extended service life, NSK duly recommended switching to its Molded-Oil bearings with DDU seal, which ensured protection against the ingress of dust produced by the slotting operation. As a result of the project, bearing life has quadrupled from 2-3 months to 12 months, saving over €38,000 per annum in downtime costs alone.
