# Case Study POWER TRANSMISSION

Application: CRANE RE-DESIGN

# The biggest single challenge ERIKS Power Transmission ever faced

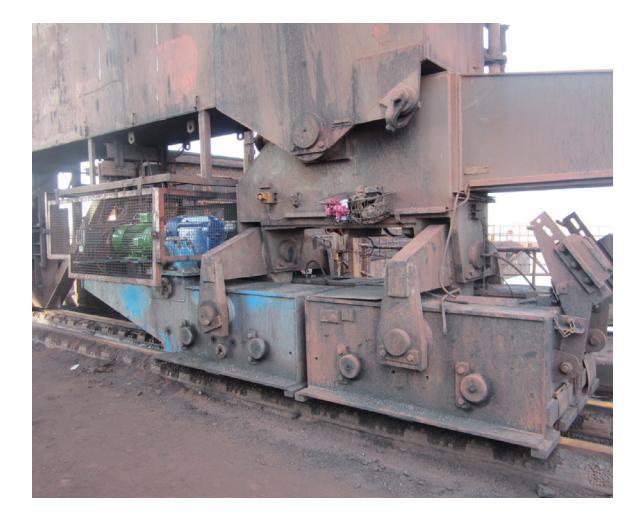
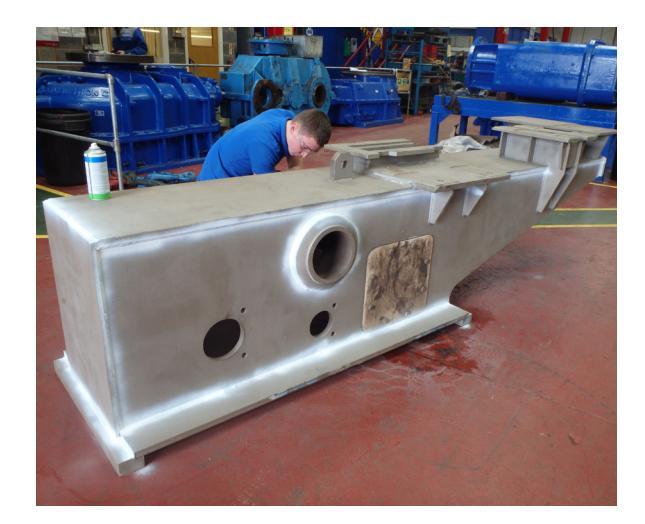
Essentially, the project was to re-design an efficient drive without the open gears, but one of the initial issues faced was the amount of carriages available. It was concluded that altogether there were 10 carriages, but the crane required a minimum of eight to operate, meaning that at one given moment, the crane would not be in working order - this left no option but costly downtime.

As the bearings carried the lion share of the weight, we acquired the assistance of SKF to calculate the loading on the shaft to design a bearing arrangement from imperial taper roller (which were limited availability and great expense) to modern spherical roller bearings that would handle the excessive loads.

It was also decided that new wheels would be requried to incorporate the new bearing arrangment - a suggestion ERIKS made at an earlier stage to reduce both the cost of the wheels and maintenance.

Following a new and improved blueprint, we were able to strip a lot of machining and materials off the original design, making them approximately 100-200kg lighter. Subsequently, 10 of these were ordered.

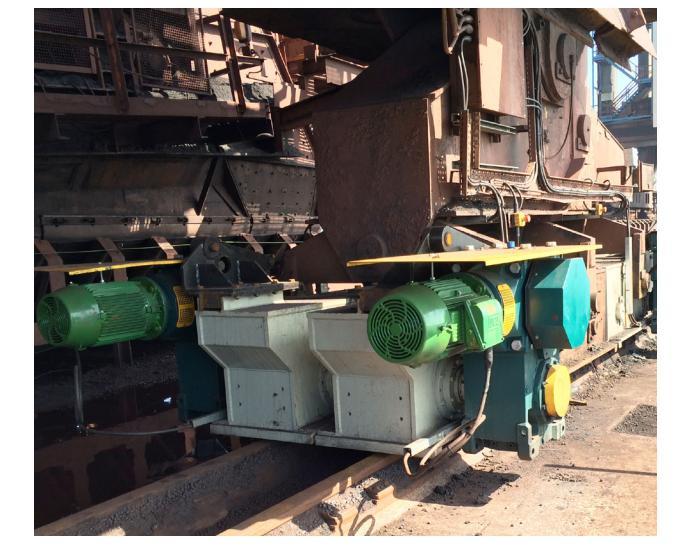
In addition, we also designed and installed a better solution for the braking of the cranes by fitting an IP65 enclosed electromagnetic braking system to the Fenner gearbox.

The final installation was a clear success, exceeding the clients expectaions by delivering a more efficient design that eliminated the worry of exposed components, hence reducing both maintenance times and costs, together with loss of production.
