ERIKS starts a savings chain reaction

Productivity and cost-efficiency on the move

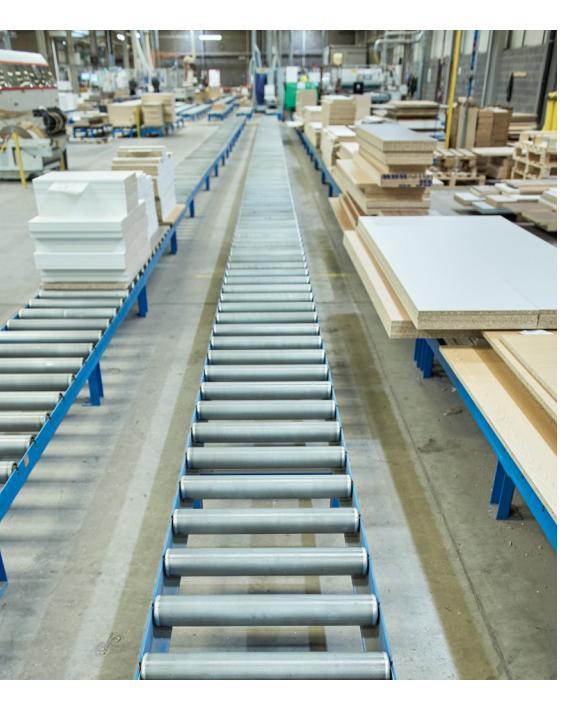
Wooden skid boards are used to carry product along the customer's chain conveyor system. The steel U-type attachments on the conveyor were damaging the skid boards – and occasionally the products.

The damage to the products meant a reduction in productivity and cost-efficiency. The damage to the skid boards meant more frequent breakdowns and less reliability. Wood splinters and fragments from the damaged boards were finding their way into the conveyor mechanism and rotating equipment – such as bearings – leading to equipment failure, downtime, and increased maintenance costs.

Conveyor system used to transport materials

After the visit, ERIKS proposed the use of Renold Klik-Top[™] Chain, which is designed specifically to reduce damage to conveyed goods and to simplify and minimise maintenance.

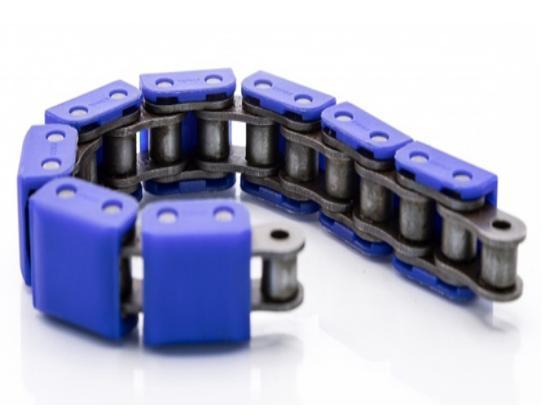
The Klik-Top fixes onto the chain with one click, and can be removed just as easily – so replacement only takes a moment. There are no sharp edges in contact with the conveyed goods, and when the chain passes over the sprocket the clip's rounded edges prevent any damage. In addition, as the Klik-Top fits over the pins, it protects the chain's bearing areas from dirt and other contamination.

Renold Klik-Top Chain

The Renold Klik-Top Chain was quickly and easily fitted onto the existing conveyors, with no installation issues or interference from rivets, or other components or equipment. The chain runs without causing any damage to skid boards, which in turn means no wood splinter shavings to fall into the rotating equipment, causing breakdowns and downtime.

The chain components last longer, which increases the reliability of the conveyor system, optimises productivity and reduces replacement costs. The Klik-Top Chain also requires no lubrication for four years, which represents a further saving on lubricants and labour costs.
