<b>Industry:</b>	Metals
<b>Application:</b>	Conveyor Drive
<b>Actual Saving:</b>	£n/a
<b>Payback Period:</b>	n/a

## Drive Unit Repair for Conveyor Line

ERIKS help customer avoid 18 -22 weeks of downtime with drive unit repair

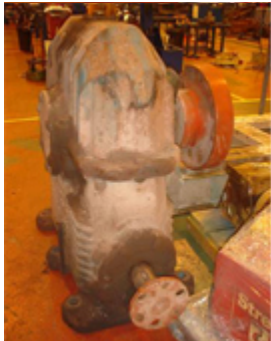
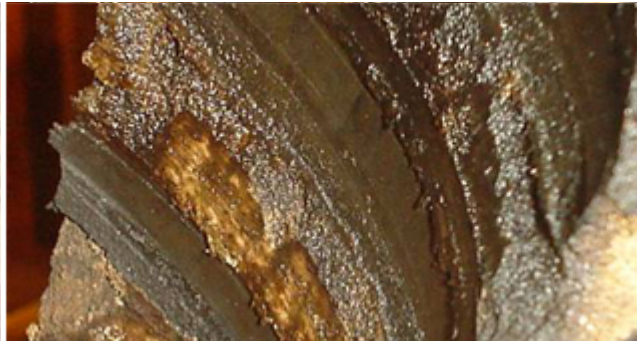
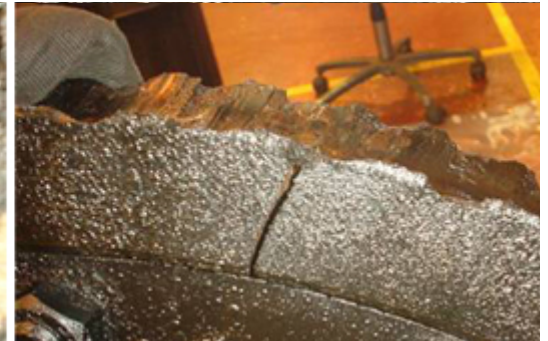
The customer, a large steel producer, experienced an onsite failure to a conveyor drive unit that transported coal from the yard up a conveyor and into the plant for distribution to the furnaces. The drive unit failed because the conveyor anti run back device had failed when the line was loaded with over 500 tons of product that was sitting on an incline. The drive unit internals held for a short period of time until the teeth broke and then due to the momentum of the conveyor with the load, the internal gearing stripped away.

ERIKS were contacted and collected the drive unit. A strip down inspection revealed the drive unit had sustained a catastrophic failure and needed a full set of internal running gears. This drive unit was obsolete and a new equivalent drive was on an unacceptable lead time of 18 - 22 working weeks.

ERIKS were able to trace a full set of internal gears for this old drive unit which were installed into the unit as part of a full overhaul on a breakdown service, allowing the drive unit to be overhauled and returned back to site within 48 hours.
