Bridging the Gap: Upgrading Outdated Infrastructure One Tank at a Time

Water & Wastewater

Settlement tank drive systems

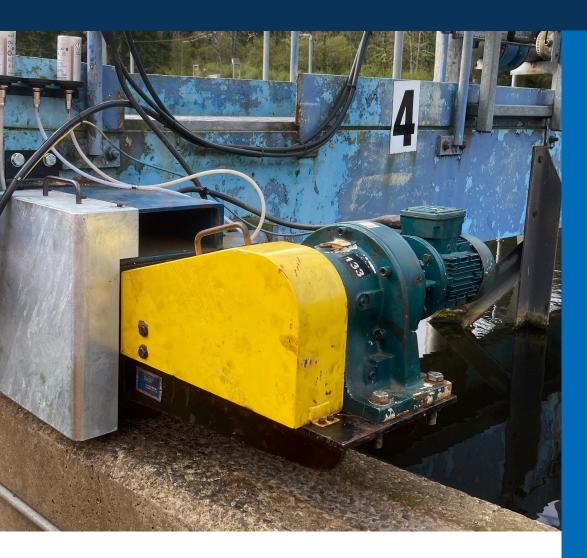
At a wastewater treatment plant in Scotland, ageing infrastructure was beginning to show its limits. The site features a series of round settlement and storm tanks that rely on motorised bridges to keep water in motion and prevent solids from settling on the bottom.

However, many of the bridge drive systems were outdated, worn, and difficult to maintain. Across the site, 20–30 drive units were in various stages of disrepair. Frequent failures - especially in motors and bearings - were disrupting operations and threatening the site's ability to maintain optimal performance.

- Outdated designs using open bevel gears and unsupported shafts
- Increased loads from added equipment like aeration systems
- Limited access due to handrails and tank positioning
- High maintenance demands with minimal standardisation of parts
- Severe weather exposure, which caused snow buildup and further complications

ERIKS was called in to reassess the entire drive system on the final settlement tanks. Working closely with the customer and site engineers, ERIKS helped co-design a robust, low-maintenance solution that addressed both performance and safety challenges.

The Fenner Cyclo foot-mounted gearmotor was chosen for its high torque, compact footprint, and maintenance-free operation. The chain drive was retained for its torque transmission efficiency but repositioned inboard to avoid interference with railings and improve service access.

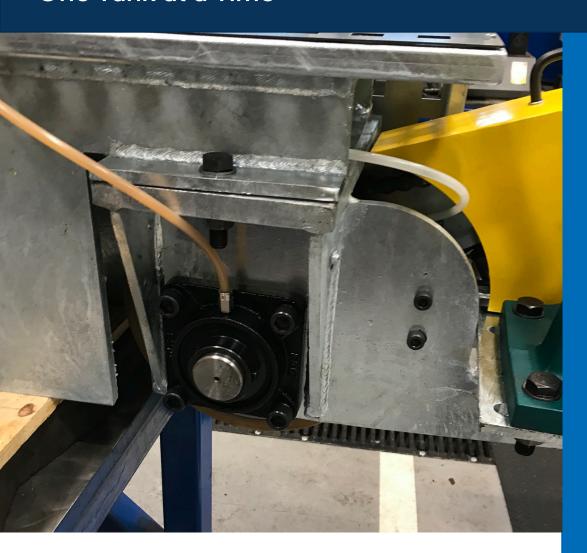
For bearing performance, ERIKS specified Timken® spherical roller bearing solid-block housed units - engineered for high-load, high-contamination environments. Unlike conventional bearing housings, these solid-block units feature cast-steel housings and high-performance Timken bearings, offering unmatched strength and durability. With the ability to tolerate shaft misalignment up to ± 0.75 degrees without reducing bearing life, they were ideally suited to the site's structural challenges.

Further upgrades included, a fully guarded drive systems to meet current health and safety standards. The addition of an automatic lubrication system to maintain chain and bearing health with minimal intervention, along with a custom 'snow plough' attachment with a wiper blade to prevent snow build-up and bridge stalling during severe weather.

The new system not only solved the mechanical issues, but also dramatically simplified maintenance. ERIKS then rolled out the same upgrades across the site's primary and secondary tanks, incorporating the same Cyclo drives, bearings, wheels, and shafts creating a universal setup with interchangeable spares.

On the primary tanks, further design refinements allowed for a built-in jacking system, enabling service without the need for expensive lifting equipment.
